# Troubleshooting

*Cepheid HBDC Training Centre*

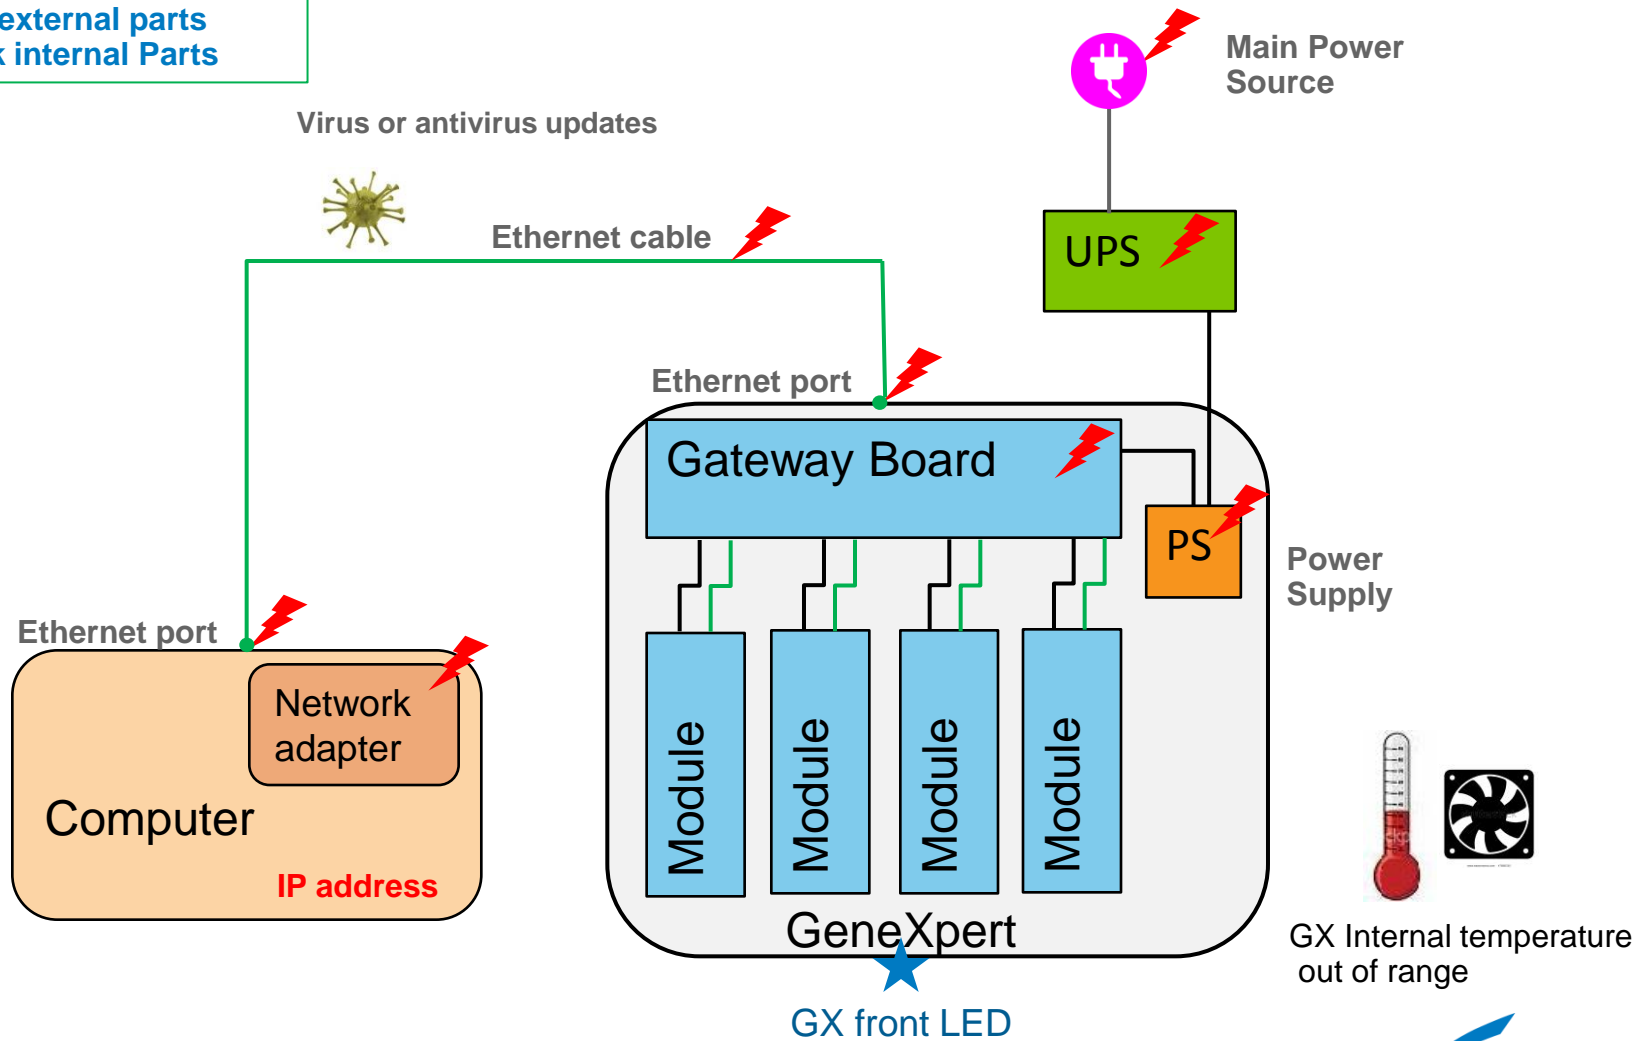
# Whole GeneXpert not detected

First check external parts  
Then, check internal Parts

1. First switch on the GeneXpert then, the computer (restart)
2. Is the front blue LED illuminated? If not, check the power source is functional
3. Ethernet cable : check for visible damage + Reconnect
4. Room temperature (15-30°C)
5. Fan functionality and filter cleanliness

1. GeneXpert power supply
2. GeneXpert gateway board...
3. Ethernet ports (Computer & GX): swap with another GX/computer
4. Network adaptor: wobbling, loose?

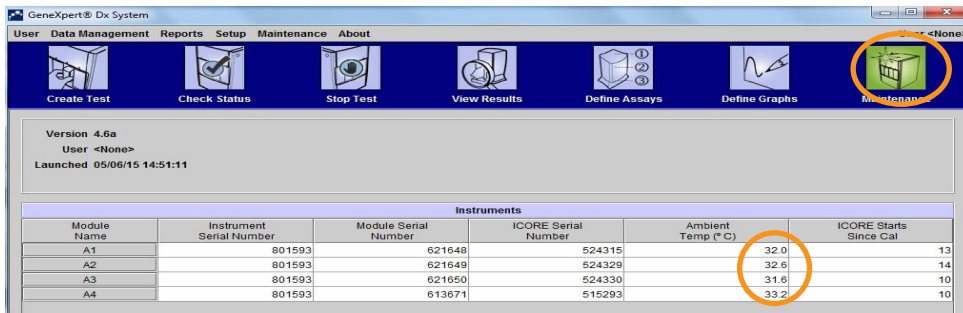
- **Identify the affected module (s): Serial number and position**
- **Check the module(s) internal temperature**
  - Click on the Maintenance icon and check « Ambient Temp » for each module. You may have to report these values when you contact Cepheid Technical Support
  - Check fan functionality\* and filter cleanliness

Instruments						
Module Name	Instrument Serial Number	Module Serial Number	ICORE Serial Number	ICORE Serial Number	Ambient Temp (*C)	ICORE Starts Since Cal
A1	801593	621648	524315		32.0	13
A2	801593	621649	524329		32.6	14
A3	801593	621650	524330		31.8	10
A4	801593	613671	515293		33.2	10

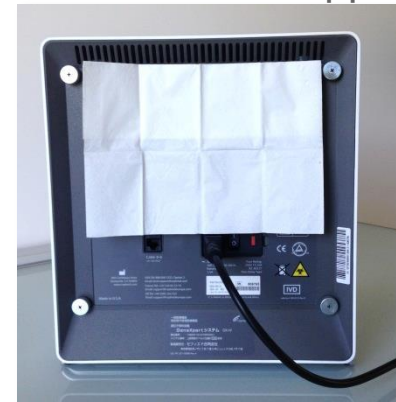
\*Place a wiper on the filter and check if it remains stuck to the back panel
